**National
Transportation
Safety Board**

Helicopter Case Studies

Case Study 1

- MD Helicopters 369D
- One Rolls-Royce 250-C20B
- Near Oso, WA
- July 22, 2014
- Injuries: 1 serious
- NTSB Case No. WPR14LA308

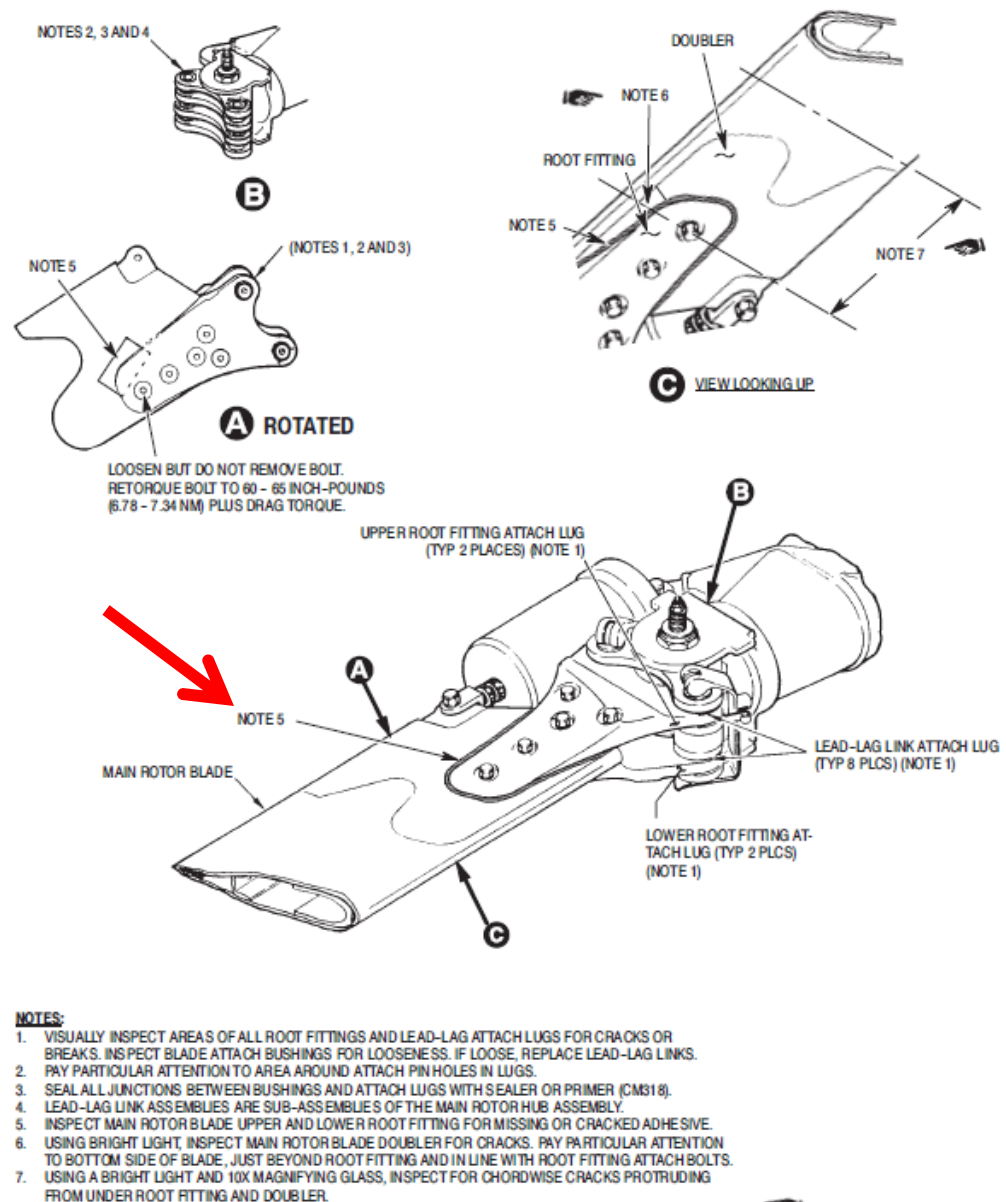
Original Procedures
(pre-accident)

- (1). Lifting from the outboard end of the blade, lift blade off the droop stop.
- (2). Inspect the bottom-side of the blade as follows:
 - (a). Using a bright light and 10x magnifying glass, inspect for chordwise cracks protruding from under root fitting and doubler (View C and Note 7).

- (b). Inspect the area around the root fitting, doubler and skin for cracks.
 - (c). Inspect the attach lugs at the bushings for cracks.
 - (d). Inspect the entire length of the blade for cracks.

- (e). Lower blade back onto droop stop.
- (3). With blade resting on the droop stop, inspect the top-side of the blade as follows:
 - (a). Inspect the area around the root fitting, doubler and skin for cracks.

- (b). Inspect the attach lugs at the bushings for cracks.
 - (c). Inspect the entire length of the blade for cracks.
- (4). If any of the above defects are found, the main rotor blade is to be rejected and scrapped.

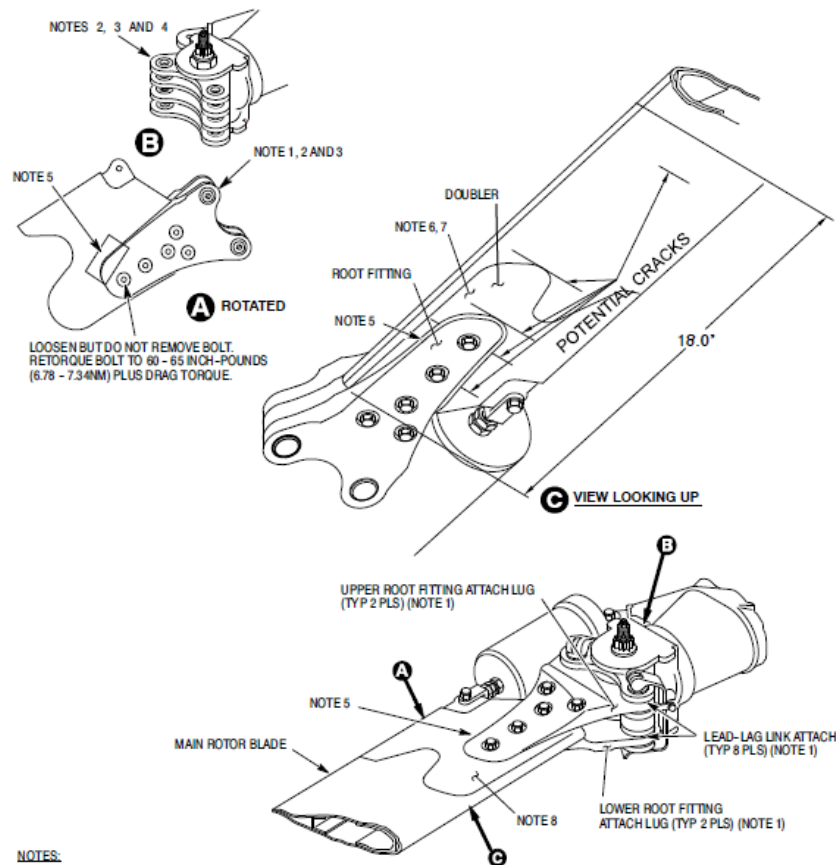
- (1). Lift blade off the droop stop from the outboard end of the blade.
- (2). Inspect the bottom side of the blade as follows:
 - (a). Use a bright light and 10x magnifying glass, inspect for chordwise cracks protruding from under root fitting, doubler, and skin. (View C and Note 6 and 7).
 - (b). Inspect lower root fitting for missing or cracked adhesive/paint around the periphery of the root fitting. If this condition exists, perform the upper and lower root fitting inspection. (Ref. Main Rotor Blade Upper and Lower Root Fitting, Attach Lug and Lead-Lag Link Attach Lug Inspection (100 Hour)). (Figure 604, Note 5)
 - (c). Inspect the attach lugs at the bushings for cracks.

- (d). Inspect the entire length of the blade for cracks.
- (e). Lower blade back onto droop stop.
- (3). With blade resting on the droop stop, inspect the top side of the blade as follows:
 - (a). Use a bright light and 10x magnifying glass, inspect for chordwise cracks protruding from under the root fitting, doubler, and skin. (Figure 604, Note 8)
 - (b). Inspect upper root fitting for missing or cracked adhesive/paint around the periphery of the root fitting. If this condition exists, perform the upper and lower root fitting inspection. (Ref. Main Rotor Blade Upper and Lower Root Fitting, Attach Lug and Lead-Lag Link Attach Lug Inspection (100 Hour)). (Figure 604, Note 5)
 - (c). Inspect the attach lugs at the bushings for cracks.
 - (d). Inspect the entire length of the blade for cracks.
 - (4). If any cracks are found, the main rotor blade is to be rejected and scrapped.

- Service letters released by airframe and blade manufacturers to clarify TE inspection and highlight inspection requirement of fitting bond line cracks.
- Also modified the maintenance manual to better highlight the inspection requirement for fitting bond line cracks.
